Chollas Creek Total Maximum Daily Load (TMDL) 2009 - 2010 Water Quality Compliance Monitoring

*Final Report
November 8, 2010*

Weston Solutions, Inc.
2433 Impala Drive
Carlsbad, California 92010

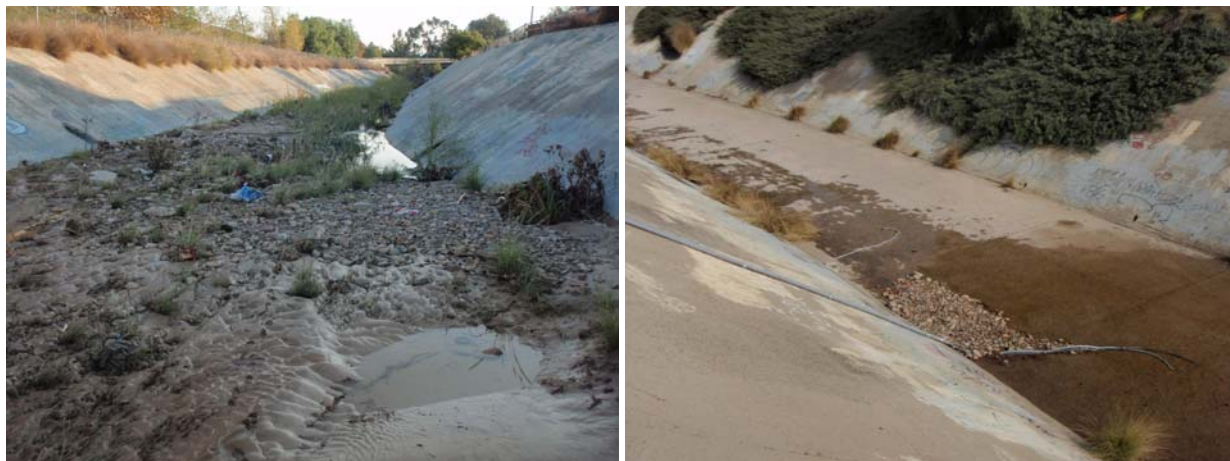
Figure 3-1. Sediment and Cobbles at Original SD8(1) Site (left) versus Relatively Clean Channel Cross Section at New SD8(1) Site (right) – December 2009

Compliance monitoring location SD8(1) was historically located at the end of Durant Street, east of 33rd Street, and approximately 750 ft south of Imperial Avenue. During the 2008–2009 Monitoring Season, sensor readings were impacted due to sediment accumulation where the sampler intake and pressure transducer were located in the channel bottom. A field survey on September 10, 2009 indicated that accumulated sediment and large cobbles would once again impact sensor readings. Therefore, SD8(1) was relocated to a comparable channel cross section of Chollas Creek that would be less impacted by cobbles. SD8(1) was relocated approximately 100 yards upstream of the original site, at the end of Steel Street (lat: 32.70553, long: -117.12121). Field survey notes for the new SD8(1) trapezoidal channel cross section have been provided in Appendix A.

During the 2009-2010 Monitoring Season photos were taken at both the original and current SD8(1) monitoring location to document the differing channel conditions (Figure 3-1 and Figure 3-2). Generally, the accumulated sediment pictured at the new SD8(1) site was deposited after monitoring was complete and washed away during the first flush of water of the monitored event.

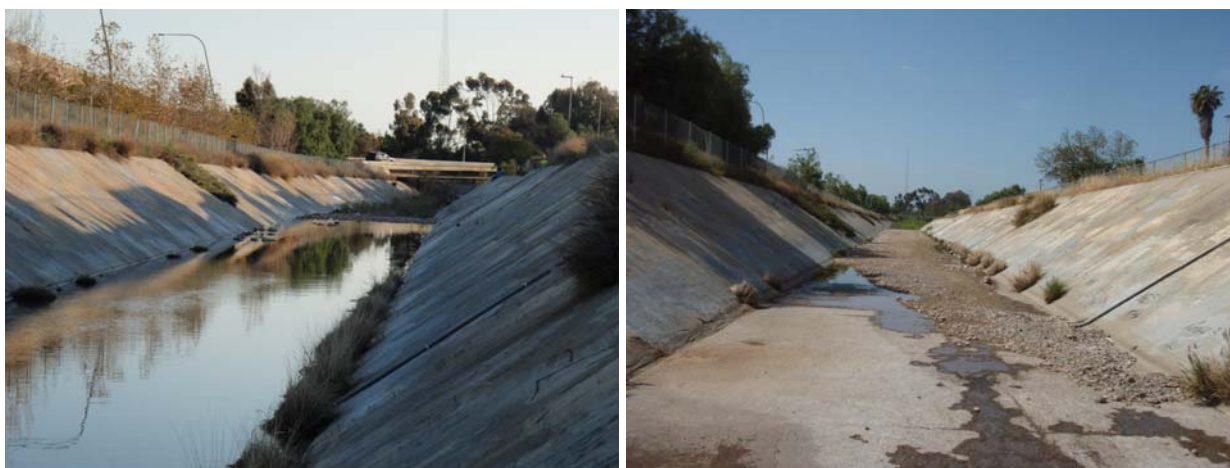
Figure 3-2. Wide-Angle View of Chollas Creek Showing the New SD8(1) Site in the Foreground, Original SD8(1) Site in the Mid-Photo, and Accumulating Sediment and Cobbles in the Background – February 2010 (left) and May 2010 (right)
